TIME & MONEY

When it comes to maintenance it seems owners follow one of two approaches, one highly recommended, the other . . .
. . . not so much.

By BILL ANDO

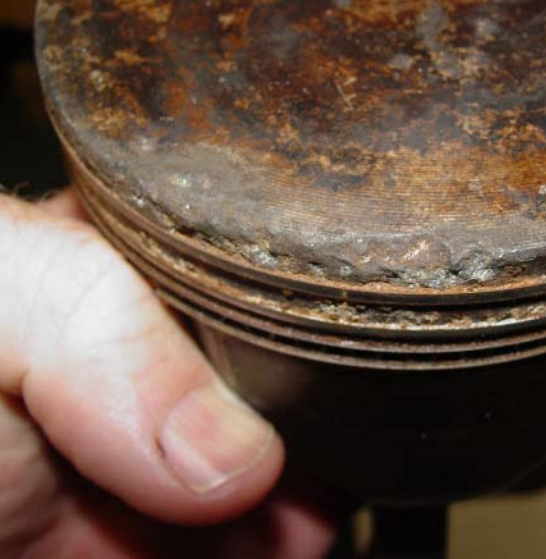
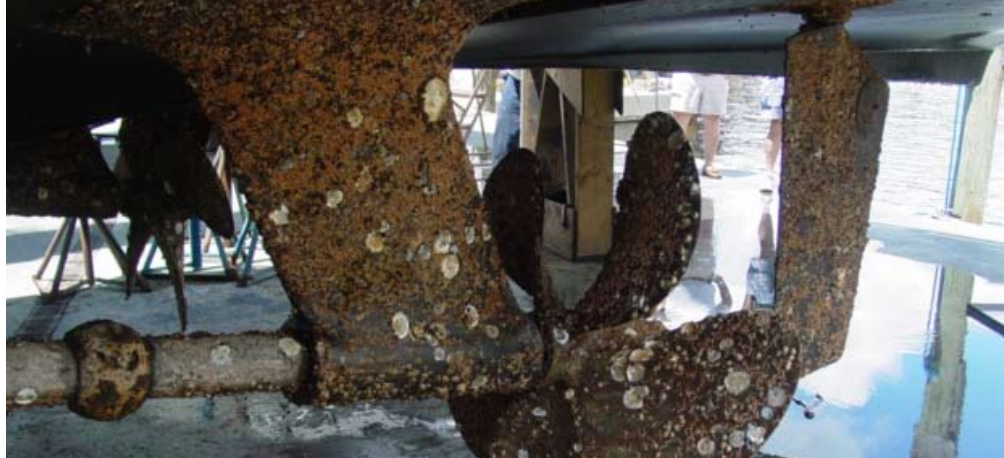
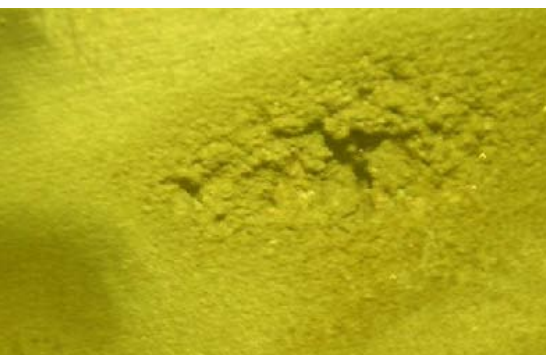
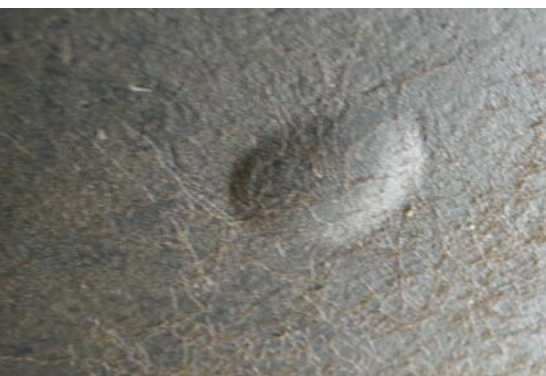
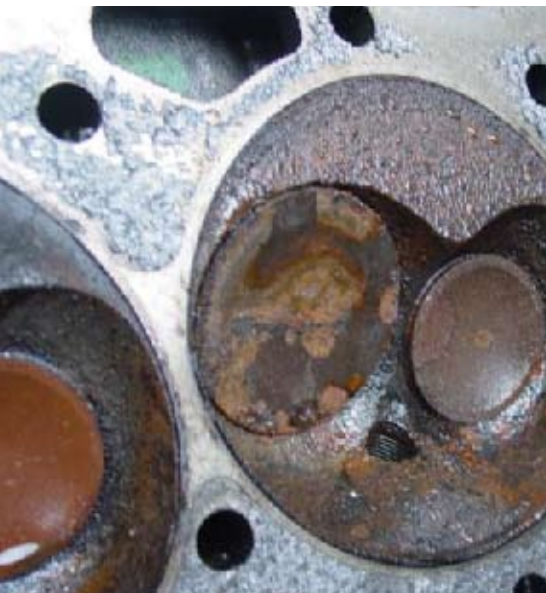
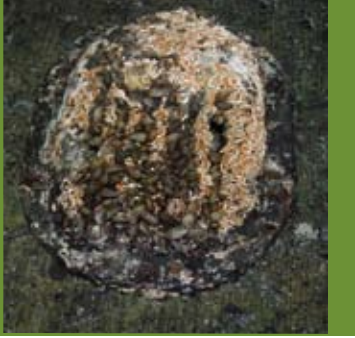
Clockwise, from bottom opposite: Signs of risers leaking sea water into cylinders; blister signals water has penetrated the gelcoat; a diver's photo of a prop cavitation burn found during cleaning; this piston is beyond ring replacement; this running gear will have a serious impact on performance; a raw water strainer that doesn't.

"When I went to the boat," Bill recalls, "I saw the telltale signs of rust between the riser and manifold, that any mechanic could have seen during regular maintenance." He pulled the spark plugs; two of them were solidly rusted. Uh oh. Bill discovered that the risers had been slowly leaking exhaust water into the exhaust manifold.

"Once the engine shuts down, water finds its way into the cylinders where the exhaust valves are open and then the saltwater seizes the rings," he says. To make things worse, the boat was being listed for sale. "We pulled the engine out and installed a new long block." What would have been a \$1,250 repair became a \$10,000 engine replacement. Not using a boat doesn't mean that you needn't haul it.

into the yard at idle speed, its engines and generators overheated under load. The air conditioners, without adequate cooling water, were malfunctioning. When they hauled the boat they found massive growth and 800 weeping blisters.

Instead of a pressure wash and a bottom paint job costing \$3,500, the project began with a charge of \$3,300 just for scraping and grinding the bottom to assess the depth of the problem. The necessary fix? Remove all the bottom paint and grind out every blister then wash out those areas, let them dry, fill every hole with the proper lay up, followed by barrier coat then primer and bottom paint. "The job will likely cost approximately \$26,000. The blisters, if caught earlier during yearly bottom painting, would have been much smaller in size and quantity," he says. The moral of the story is that it's easy to fall into the rut of a Deferred Maintenance Program, but not so pleasant climbing out. Bill Dalton can be reached at apexmarinerepair.com. 🐛
